INFO SHEET

Algae and Coatings

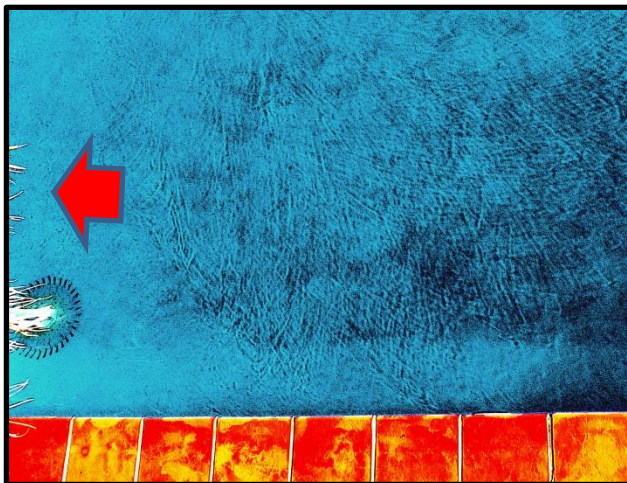
Here we can see “stains” ahead of the creepy crawler (vacuum pool cleaner) towards the right-hand corner where the surface is quite rough. The original pool surface area around the creepy crawler is quite smooth and thus cleaner.

There is over hanging vegetation just visible on far left as well. (see arrow)

So, in this case the overhanging vegetation has led to matter falling into the pool, rotting and in areas where the original concrete surface is rough, with hills and valleys, algae forming in the bottom of the valleys, highlighting them, giving the appearance of a faulty coating.

Treatment is quite straightforward, remove all overhanging or nearby vegetation, including palm trees and resultant seeds and nuts. Then use a good algaecide (from pool shop), some brooming and vacuuming to remove residues.
