INFO SHEET

Assessing Below Ground Pools for Ground Water Issues

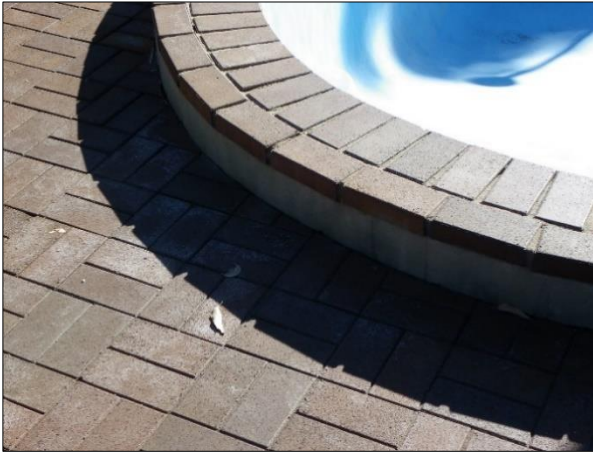
Figure 1 Dark pavers and coping with efflorescence present, with drainage. Resulted in blisters on pool walls

- Efflorescence is a very good indicator of water being in the concrete (or in the ground surrounding the pool) and as the water moves in and out of the substrate, leaving behind the white powder (efflorescence) as the liquid evaporates.
- Dark colour pavers or coping tiles on the tops of pool walls can heat up on summer days. Due the thermal differential with the bottom of the wall (being buried and much cooler) creates a wicking effect with ground moisture. The moisture rises up the walls and leaves near the top, often leaving telltale white efflorescence too.
- Any blisters in the existing pool coating, will indicate moisture passing through the concrete shell into the pool (hydrostatic pressure). Note: A well-worn, thin pool coating may not show

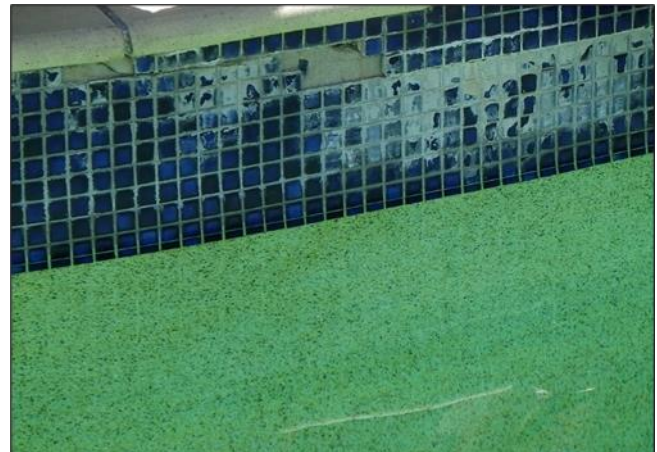
Figure 2 So many water related issues resulting in tiles being lost. Note the area below the tiles, being porous it looks OK.

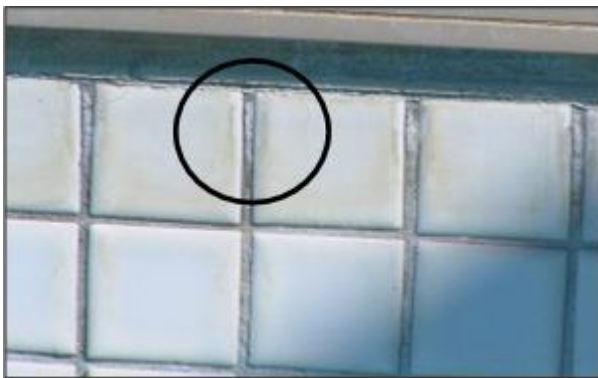
Figure 3 Showing telltale efflorescence on tile grout indicating water passing out from pool shell.

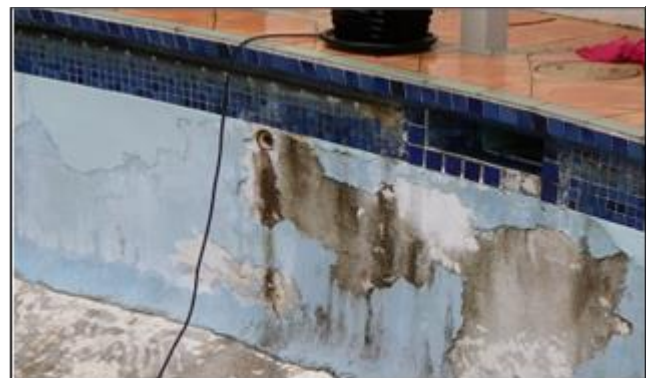
Figure 4 Effects of poor drainage around pool and causing in part delamination of render.
